How it was: an operator's perspective

19 April 2006

Anatoly Dyatlov, the former deputy engineer for operations at Chernobyl, and the senior officer on the night of the accident, gives his side of the story. He thinks the reactor operators have been unfairly singled out for blame (having himself served four years in prison) and believes the accident was attributable entirely to design faults. [Article published in [NEI November 1991](#)]

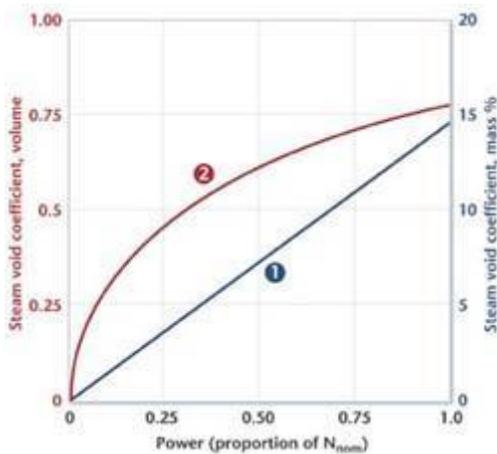
At this point it should be mentioned that there was no violation of any instructions when the staff began to reduce the power. Before the accident there were no restrictions on reactor operation at any power level. The regulations directly specify that operation at a minimum controlled power level is not limited to any particular duration. The reason why the reactor became dangerous at low power level can be readily understood from Figure 1. At low power level a given power increment results in an increase in steam volume in the coolant which is many times more than at nominal full power (N_{nom}). The resulting fast power coefficient of reactivity, to which the negative Doppler effect of fuel and the positive steam void effect contributed, turned out to be positive. Its specific value has been reported neither by the scientists (the Kurchatov) nor by the designers (RDIPE), although it is hard to believe that they have not calculated it after the accident. It is difficult to say whether those who created the reactor were aware of this phenomenon, which is a direct consequence of the thermal hydraulic configuration adopted. What is absolutely clear, however, is that this phenomenon was not accounted for in practice.

Figure 1. Mass (1) and volume (2) steam void coefficient of coolant v reactor power for Chernobyl 4. At low power a given power increment results in much greater voiding than when the plant is at nominal full power (N_{nom})

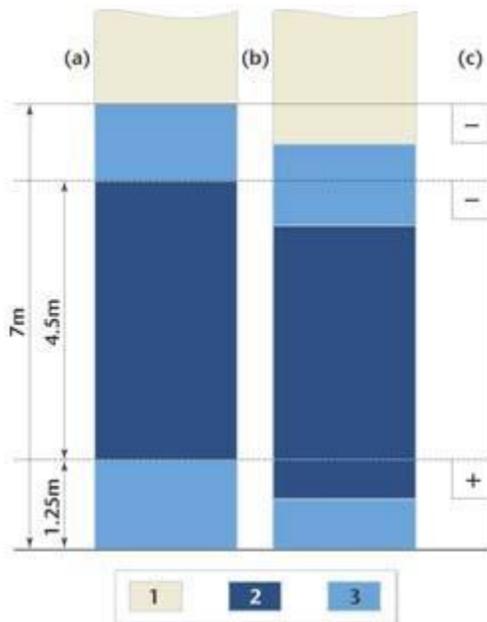
Figure 2 shows schematically the design of control rods as used in the reactor control and protection system. To eliminate parasitic absorption of neutrons by the water column in a control and protection system channel when the absorbing control rod is raised, a 4.5m long graphite displacer was suspended from it. Therefore when the control rod is in contact with the upper limit switch, the displacer is positioned in the middle of the core and there are water columns

1.25m high in the upper and lower parts of the core. During the downward insertion of a rod into the upper part of the core the absorber introduces negative reactivity and the displacer, displacing water, introduces positive reactivity into the lower part. If the maximum neutron flux is shifted to the lower part of the core, then during the first 3 seconds of rod movement (rod insertion speed = 0.4 m/s) the shutdown system introduces net positive reactivity. At low values of ORM most of the control rods are out of the core and the actuation of the emergency protection system by trip signal or by pushing the trip button sends all the rods into the core.

Figure 2. The control rod arrangement at Chernobyl. The initial effect of rod insertion is to introduce positive reactivity into the bottom of the core. Key: 1 - absorber; 2 - graphite displacer; 3 - water; a - rod out of the core; b - beginning of insertion; c - sign of reactivity introduced

But owing to the core's large height its lower and upper parts behave, especially when the central area of the core is heavily poisoned, rather like two independent reactors. The effect of the rods inserting is to create in the lower part of the core a local critical mass, and the neutron distribution tends to shift downwards irrespective of where it was before the protection system trip. The power in the lower part of the core begins to increase and then the positive fast power coefficient of reactivity comes into play. The fatal loop gets closed. Paragraph 3.3.28 of the Soviet Nuclear Safety Rules states: "The quantity, positioning and actuation speed of components of the emergency protection system must be specified and validated in the reactor design, where it should be shown that in any emergency conditions and in the event of non-actuation of the single most effective element, the actuating components of the emergency protection system provide: a rate of emergency reduction in reactor power sufficient to prevent potential damage to fuel exceeding tolerable limits: and prevention of the formation of local critical masses." In the Chernobyl case, the safety rods were themselves creating a critical mass in the lower part of the core.

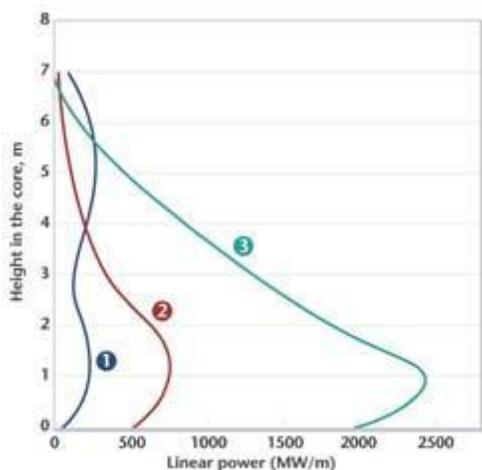
- After pushing the AZ-5 button the emergency protection system added, according to calculations, about a β of positive reactivity and created a local critical mass in the lower part of the core – resulting in a sharp increase of power there (see Figure 3) and the coming into play of the positive power coefficient of reactivity. The power in the lower part of the core rose to the level at which the fuel exploded and got dispersed.

Figure 3. Change in height distribution of core power density after pushing the AZ-5 button. 1,2,3 denote the distribution after three successive time intervals
