# Chapter 3

## Explosion

### **3.2 Causes of the accident**

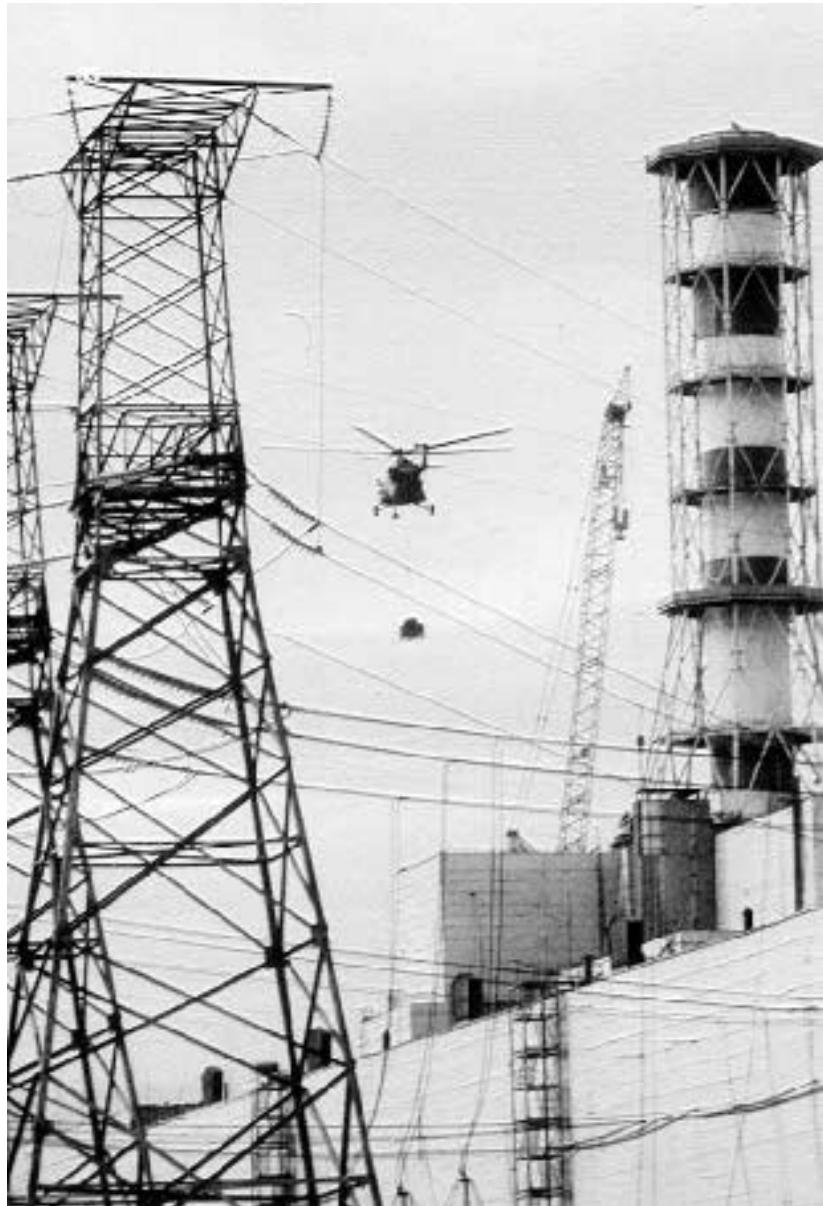
**Figure 3.7.** Helicopter flying near power lines and the ventilation stack<sup>18</sup>.  
(Courtesy: Chernobylinterinform.)

It was extremely hazardous for the helicopter pilots when flying near the electricity pylons, figure 3.7, and there was a fatal accident on 28 October 1986. This was captured on video<sup>19</sup>, figure 3.8, and there is a memorial to those who died which incorporates one of the rotor blades. This is situated by the side of the road to Chernobyl and also includes a helicopter of the type which was used. The pilots were well aware of the dangers and an Afghan war veteran is on record<sup>1</sup> as saying ‘When we heard that soldiers were being sent to Chernobyl as liquidators, we all felt we were better off fighting the war’. By 1991 it was reported that an unspecified number, *some*, of the helicopter pilots had died<sup>18</sup> and that in spite of their efforts no neutron absorbers reached the reactor core.

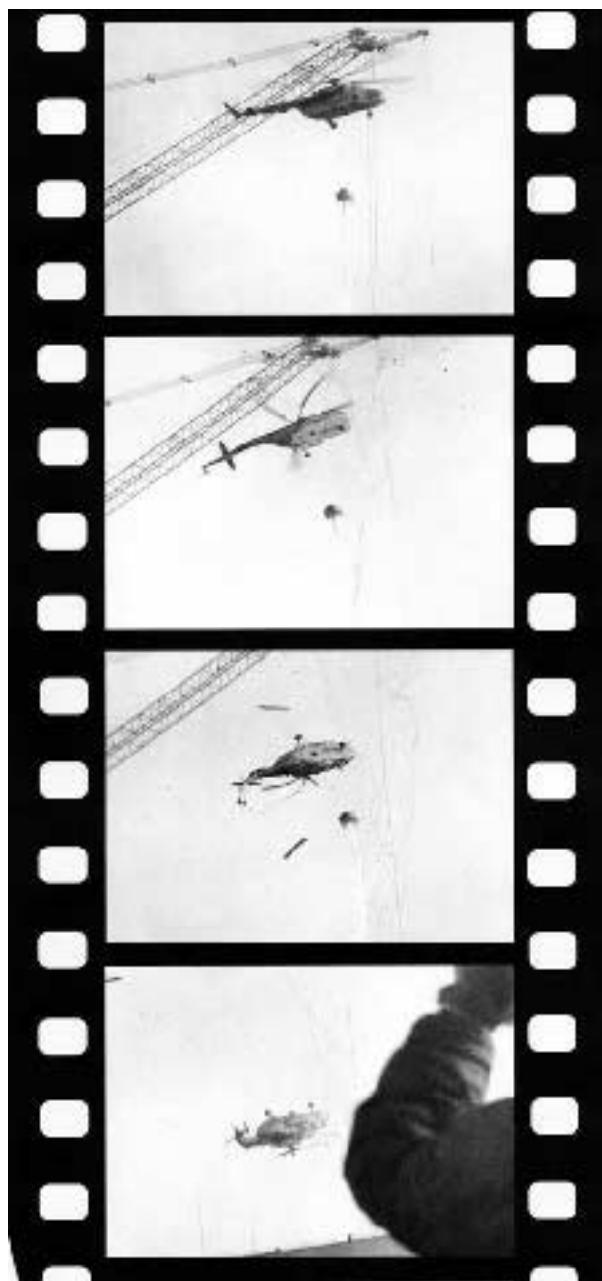
**Figure 3.8.** The fatal accident when the rotor blades crashed through a power line<sup>19</sup>. (Courtesy: Chernobylinterinform.)
